## BELZONA REPAIRS 4KM LONG CONVEYOR BELT

Repair of a 4km long conveyor belt at a copper mine.

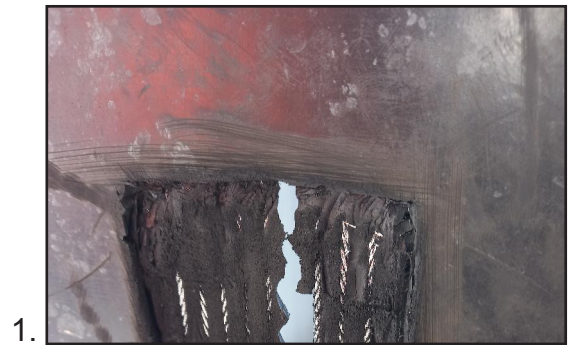
The track braking system of the conveyor belt failed causing copper ore to build up the belt. The hopper then became blocked and material began to flow out of the conveyor belt. Large pieces of ore jammed in-between the belt and driver roller causing the belt to rip in several places.

1. Before application
2. Surface preparation
3. Final application
4. Conveyor belt back in operation
