## REBUILDING OF THE WICKET GATES IN THE TURBINE OF A HYDROPOWER STATION WITH BELZONA

Re-profiling and coating of stay vanes inside of a blades inside the hydroelectric dam.

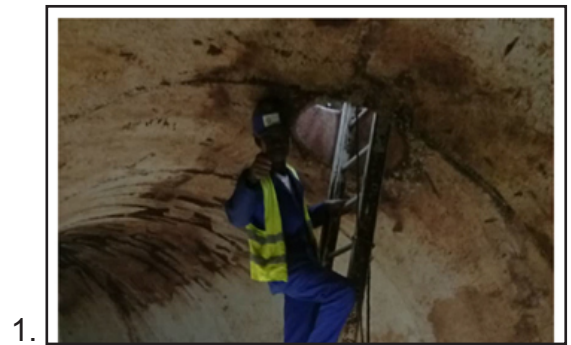
1. Diameter of the inlet penstock
2. Reconstruction of the leading edges of the blades
3. Blades reconstructed on the assemblies
4. Blades protected and finished

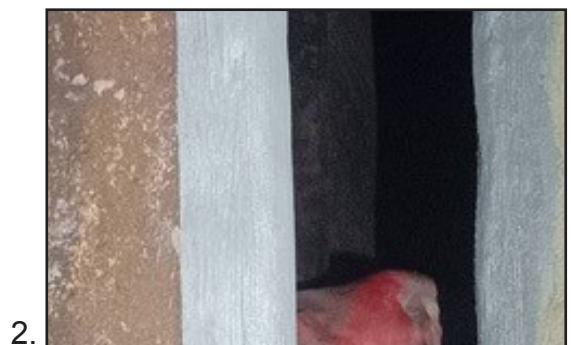
The blades suffered from damage from galvanic corrosion, which in some places reached great width. The leading edge of some blades were completely torn off.

The blades were rebuilt on the leading edges, and the holes plugged and rebuilt on the sliding sides. The whole was protected in two layers with Belzona 1321.
