ASH SILO REPAIRED WITH BELZONA 1818

Coal fired power station, Australia

Jun-21

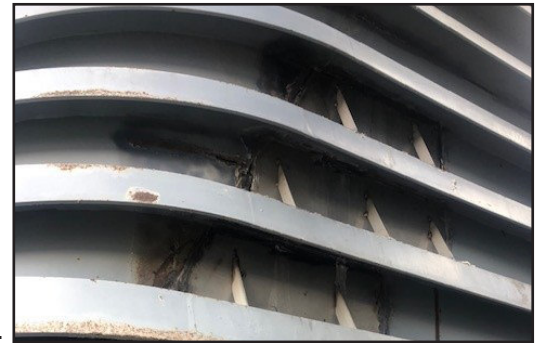
They have been experiencing rapid wear in the bottom part and particularly the Northern wall of the Bottom Ash Silo. The silo is made of 3CR12 grade stainless steel at 8.0mm thick. The wear rate is 0.25mm of wall thickness loss per month. The customer needed a quick solution to protect what metal they had left.

1. External view of the damaged Silo
2. Internal view of the damaged Silo
3. Belzona is applying
4. Application complete

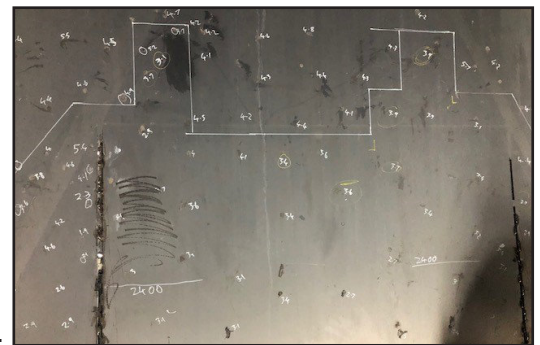
2.

There were areas in the Silo walls that had worn down from 8.0mm to 3.8mm of remaining wall thickness. Rezitech were called to offer a quick solution to reduce the metal loss and protect the remaining substrate. 20 X 1 kg kits of Belzona 1818 were applied.
