## BELZONA PREVENTS WEAR ON AN ASH SLURRY MIXER

**APPLICATION SITUATION**  
Cogen power plant ash slurry mixer

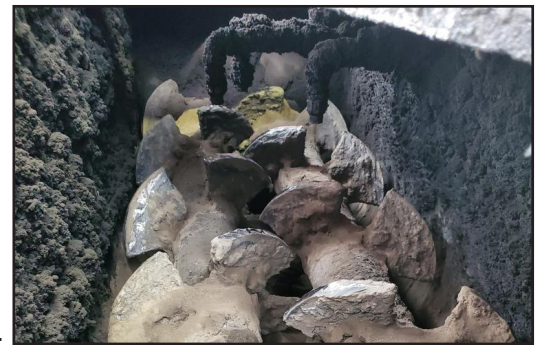
**PROBLEM**  
The paddles on their ash slurry mixer would wear down to less than half of their original length in 3 months forcing them to be replaced. The original paddles were made from hardox steel. The mixer box and shafts had some mild wear and corrosion as well.

1. Original condition
2. Box coated with Belzona 1331
3. Shafts coated with Belzona 1331
4. Paddles being coated with Belzona 1813
