HEAT EXCHANGER REPAIR & COATING WITH BELZONA

A heat exchanger had suffered damage from erosion & corrosion in service.

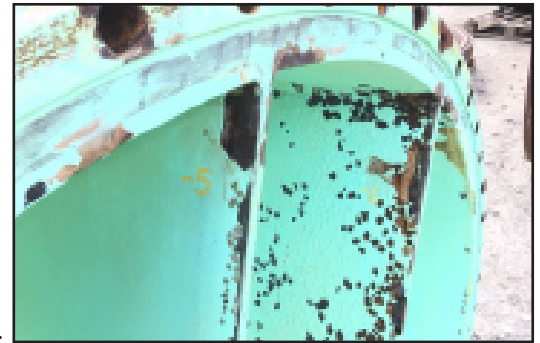
1. Damage to the coating & underlying metal
2. Surface preparation & rebuilding with Belzona 1311
3. End cover coated with Belzona 1321
4. Belzona 1321 applied

The existing coating was removed during the grit blast preparation. The metal was prepared to SA2.5 & 75 microns. Any areas of metal loss were repaired using Belzona 1311 Ceramic R metal. Two coats of Belzona 1321 Ceramic S Metal were then applied for future erosion/corrosion protection.
