BELZONA CHANGES THE SHAPE OF COLD PLATE BONDING

Offshore production platform had corroded pipe with 80% of structural loss

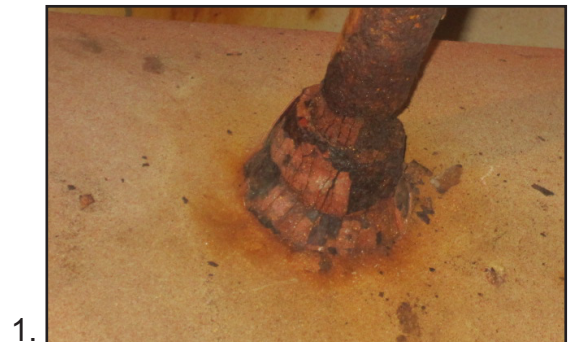
The customer had a 1" inlet into a 20" flare line. The threads of the 1" pipe were corroded and holed through. Any gas leaking out would be a major safety hazard.

1. Corroded inlet before the repair.
2. Inlet after surface preparation.
3. Test fit of plate bonding.
4. Completed cold plate bonding.
