BELZONA COLD PLATE BONDING REINFORCES OFFSHORE DECK

Offshore platform had deck areas with 60% metal wall loss

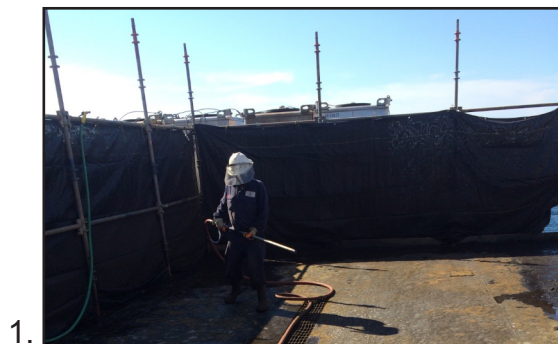
The customer had an integrity inspection performed on their steel decks as part of a life extension program. Several areas on two decks were noted to have thicknesses below the minimal thickness allowed. Some areas had holes which meant a loss of containment if there were an accidental spill.

1. Pitted and corroded deck.
2. Preparing deck and repair plate with border of Belzona 1121
3. Injecting Belzona 5811 (Immersion Grade) between repair plate and deck.
4. Completed application.

The application was carried out in accordance with Belzona BEL-CIS-100 Creating Irregular Shims and Method Statement for Cold Plate Bonding. All holes on deck were first repaired, then a perimeter bond was created with Belzona 1121. After Belzona 1121 was allowed to cure, Belzona 5811 was injected by single component airless spray into the dam created between the deck and repair plate.
