BELZONA SAVES GULF OF MEXICO FROM POTENTIAL OIL SPILLAGE

Gulf of Mexico, USA

Nov-16

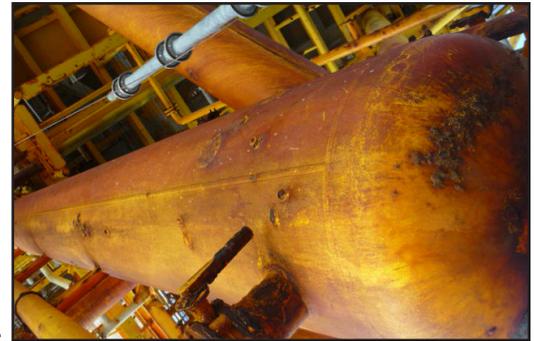
1. Blistered and corroding sump pile.
2. Through wall defect discovered during blasting operations.
3. Defective area plugged with wood and Belzona 9611 to reduce leak.
4. Cold plate bonding repair with Belzona 1161.

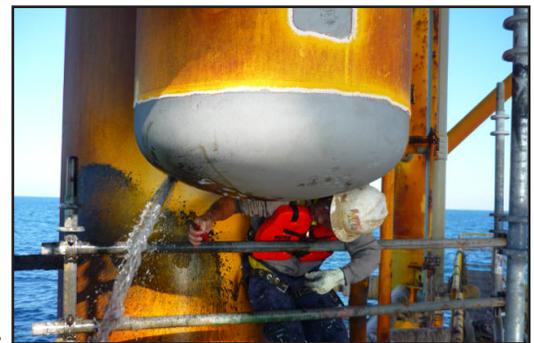
2.

The customer had a blasting and painting contractor on board to carry out routine work. While abrasive blasting a sump, a large through wall defect was discovered.
