BELZONA COLD PLATE BONDING ELIMINATES TRIP HAZARDS ON OFFSHORE DECK

Offshore platform with uneven surfaces and large holes cut through deck.

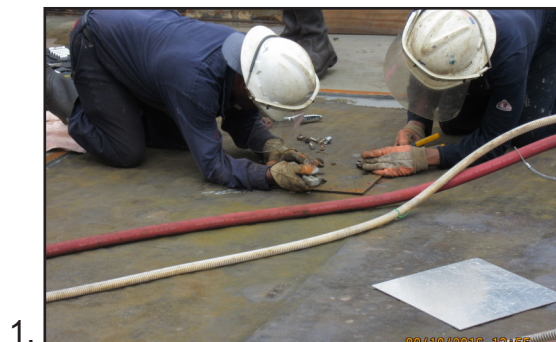
The Customer changed some equipment on their platform which required piping through an existing deck. Without a nearby penetration, the Customer cut large holes for this temporary equipment and later repaired them with bolted panels. The panels and bolts were raised nearly $\frac{3}{4}$ " above the deck surface creating a trip hazard.

1. Trip hazard plate being removed.
2. Surface prepared to near white metal.
3. Applying 1121/9341 composite repair.
4. Completed Application
