BELZONA SUPERWRAP II REPAIRS UNDERGROUND PIPELINE ADDING 15 YEARS SERVICE LIFE

High Pressure, Hydrocarbon Pipeline

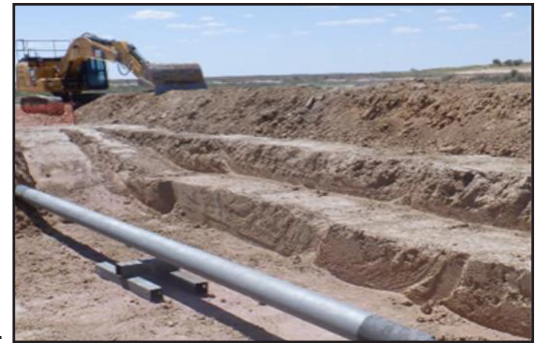
1. Pipe being excavated
2. Wetting out the substrate with Belzona 1982 resin
3. Release film over the wrap waiting to cure
4. Completed 8.1 m long application

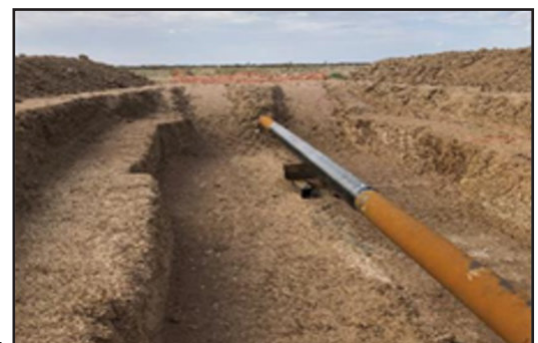
4.

The underground pipeline (O/D = 355.6 mm) had developed a critical (Class 3) thin wall defect with only 2.7 mm wall thickness remaining. The critical defect area was 56 x 83 mm, but the total defect length ended up being 8.1 m in axial. The operating temperature was 40°C and the operating pressure was 70 bar.

The application was completed in accordance with Belzona Know-How System Leaflet VPF-11. After the surface preparation by grit blasting to achieve SA2.5 with a 75 microns profile, Belzona 1111 was applied to the critical defect area to fill and smooth out before wrapping. Belzona SuperWrap II was then applied in accordance with the engineered design as a 9 wrap system with the total length of 540 mm, using Belzona 1982 resin to provide a further 15 years service life.
