BELZONA STRENGTHENS NOZZLES OF HEATING MEDIUM EXPANSION VESSEL ON OFFSHORE PLATFORM

CUSTOMER
China

APPLICATION DATE
2017

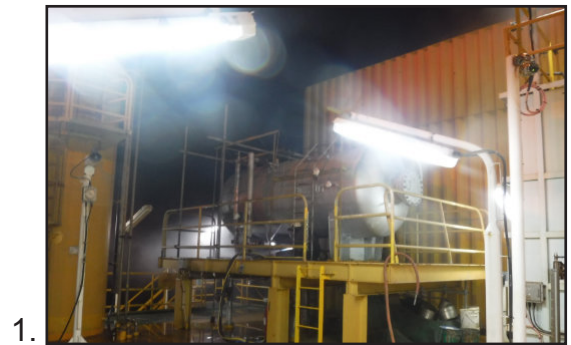
1. Surface preparation
2. Condition of nozzles after sandblasting
3. Complete application of Belzona SuperWrap II
4. View of nozzles after 3 years

The application was completed in accordance with Belzona System Leaflet VPF-11, with Belzona 1511 and 3 layers of Belzona 9341 applied. The whole application involved 2 two-inch nozzles.
