BELZONA REPAIRS NOZZLES WITH THROUGH-WALL DEFECT ONLINE ON OFFSHORE PLATFORM

CUSTOMER
China

APPLICATION DATE
2017

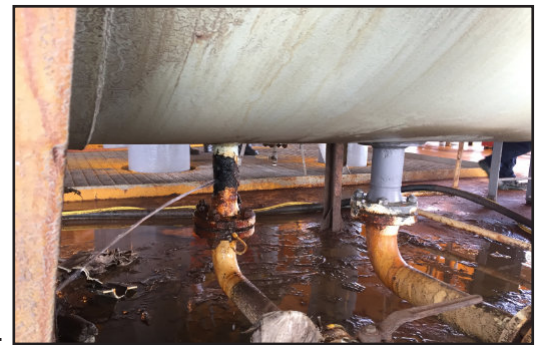
1.

PROBLEM
The nozzles of closed drain drum had developed thin-wall defect and through-wall defect due to CUI.

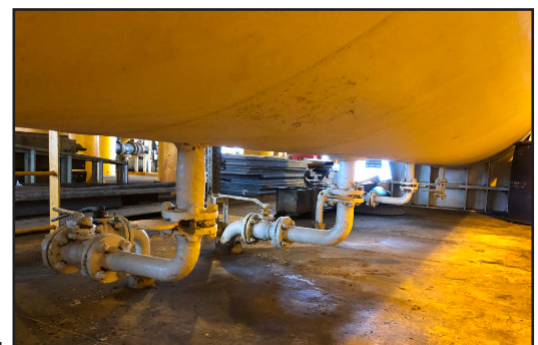
4.

BELZONA FACTS
For conventional welding, the whole closed drain drum need to be shut down and isolated, with thorough cleaning and water injection, which costs at least 15 days of downtime and affects the production. Welding in confined space may also cause hazards. Therefore, the customer has been looking for the solutions with no hot work required but also accepted by classification society. Meeting the standard of ISO24817 and ASME PCC-2, Belzona SuperWrap II can repair the nozzles of pressure vessels on-site, with no downtime or hot work required. The application is still in good condition after 3 years.
