BELZONA STRENGTHENS NOZZLES OF CLOSED DRAIN DRUM ON OFFSHORE PLATFORM

CUSTOMER
China

APPLICATION DATE
2017

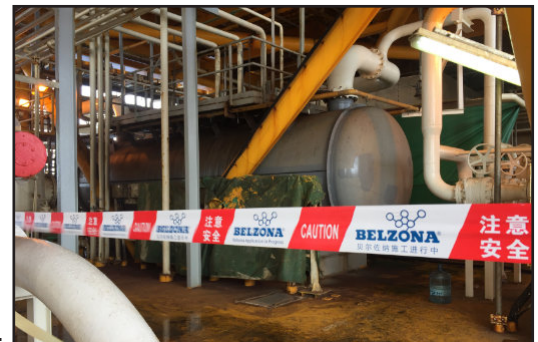
1. Surface preparation with water blasting
2. Condition of Nozzles after sandblasting
3. Complete application of Belzona SuperWrap II
4. View of nozzles after 3 years

The repairs were designed in accordance with ISO24817 standard. The application was completed by Belzona trained and validated installers in accordance with Belzona Know-How System Leaflet VPF-11. Belzona supervisor and the on-site representative supervised the whole process. The whole application involved 2 one and half-inch nozzles, 14 two-inch nozzles, 1 three-inch nozzle and 4 four-inch nozzles.

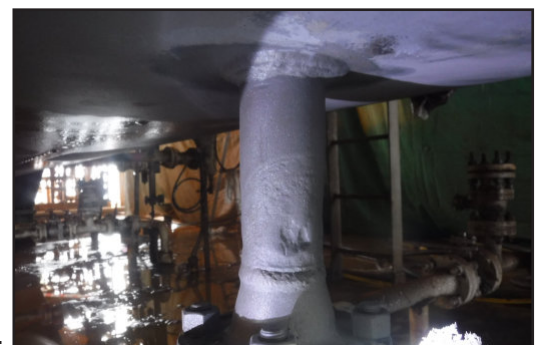
2.

The nozzles of closed drain drum had developed thin-wall defect due to CUI.

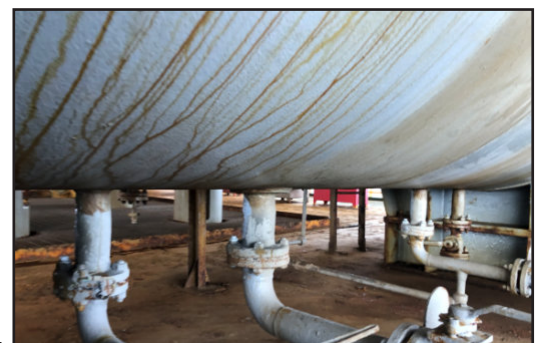
4.

For conventional welding, the whole closed drain drum need to be shut down and isolated, with thorough cleaning and water injection, which costs at least 15 days of downtime and affects the production. Welding in confined space may also cause hazards. Therefore, the customer has been looking for the solutions with no hot work required but also accepted by classification society. Meeting the standard of ISO24817 and ASME PCC-2, Belzona SuperWrap II can repair the nozzles of pressure vessels on-site, with no downtime or hot work required. The application is still in good condition after 3 years.
