BELZONA RESTORES NOZZLES OF CLOSED DRAIN DRUM ONLINE ON OFFSHORE PLATFORM

APPLICATION SITUATION
Nozzles of closed drain drum on offshore platform suffering from corrosion and significant thickness loss. The design pressure is 1.035MPa, the design temperature is -46 °C ~ 110 °C.

PROBLEM
The nozzles of closed drain tank had developed thin-wall defect due to CUI.

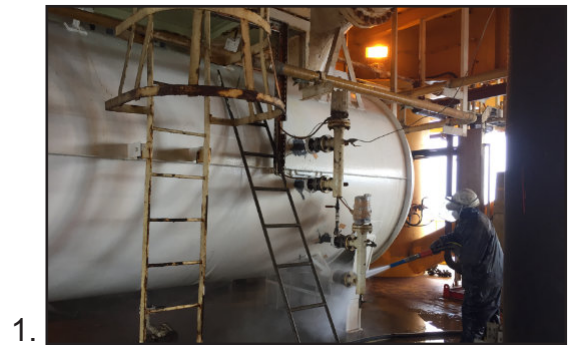
- PICTURES**
1. Nozzles during grit-blasting
 2. Condition of Nozzles after grit-blasting
 3. Complete application of Belzona SuperWrap II
 4. View of nozzles after 3 years

APPLICATION METHOD
The repairs were designed in accordance with ISO24817 standard. The application was completed by Belzona trained and validated installers in accordance with Belzona Know-How System Leaflet VPF-11. Belzona supervisor and the on-site representative supervised the whole process. The whole application involved 2 one and half-inch nozzles, 12 two-inch nozzles and 1 four-inch nozzle.
