BELZONA STRENGTHENS NOZZLES OF HIGH-PRESSURE FLARE SCRUBBER ON OFFSHORE PLATFORM

CUSTOMER
China

APPLICATION DATE
2017

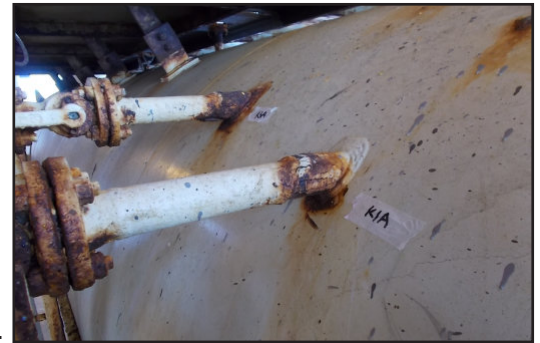
Due to the damage of the original insulation layer, the nozzle of the high-pressure flare scrubber was corroded under the insulation layer (CUI). The thickness of the nozzle was seriously reduced.

1. Nozzles with serious corrosion problems
2. Surface preparation with water blasting
3. Complete application of Belzona SuperWrap II
