## BELZONA IN THE CEMENT INDUSTRY

Ball Mill 4000mm diameter in Germany.

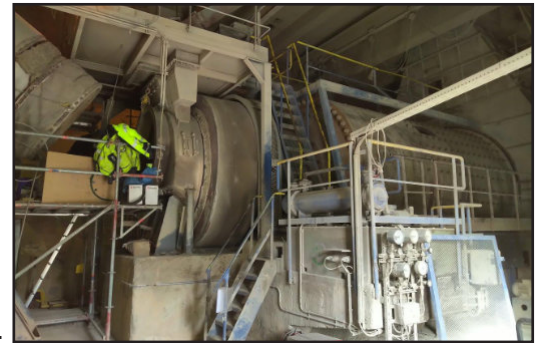
1. Ball mill in a cement plant (diameter 4000mm)
2. Belzona 4111 and steel base for the right height (for Belzona 4111 and 1812 with two different templates)
3. Every second area complete rebuild with Belzona 1812 (4mm)
4. After removing the steel base 1812 was applied in the rest of the area
