BOW THRUSTER TUNNELS REPAIRED AND PROTECTED WITH BELZONA

Bow Thruster Tunnels of Ro-Ro Vessel

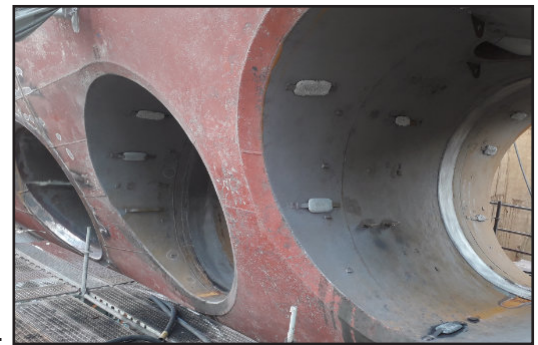
Bow thruster tunnels surface has been damaged and metal loss occurred due to high cavitation environment of propeller projection area.

1. Bow Thruster Tunnels
2. Application of Belzona 1311 for Repairs
3. Application of Belzona 1321 Coating
4. Cured Belzona 1321 Sponge Tested

Application was carried out in accordance with Belzona Know-How System Leaflets SOS-01 and SOS-02. Application surface was prepared with SA2.5 grit blasting by shipyard. Then the surface has been cleaned. Belzona 1311 was used to repair severely damaged surface. Belzona 1321 was applied on the propeller projection area to provide protection for future erosion-corrosion damages.
