BELZONA 1331 REBUILDS TURBINE COVER IN THE HYDRO POWER INDUSTRY

APPLICATION SITUATION
An International Hydro Power client needed Belzona to rebuild an area of a turbine cover.

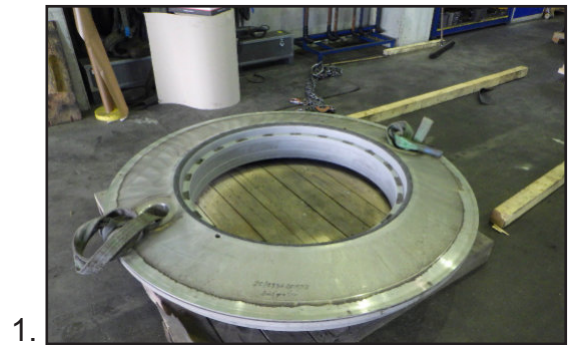
1. Turbine Cover
2. Identifying the issues 1: Worn ring (traces of erosion from the water) 2: Mating surfaces were coated in 3 layers 3: The undercut was coated in a single layer
3. The lid after applying the first coat of Belzona 1331
4. Completed application after being machined.

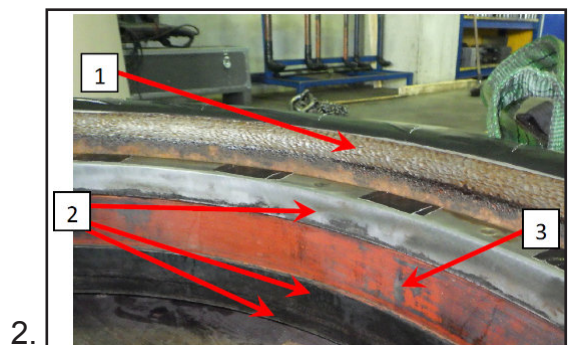
PROBLEM
The turbine cover became oval due to welding work on the outer circumference. The fits on the inside diameter also warped. Since these surfaces already had their finished diameter, they should be built up with Belzona and then machined to the finished size.
