REPAIR OF DRINKING WATER TANK WITH BELZONA 5811DW2

CUSTOMER
Poland

APPLICATION DATE
Jul-21

APPLICATION SITUATION
Renovation of a Water tank on site using a Belzona Drinking Water approved coating.

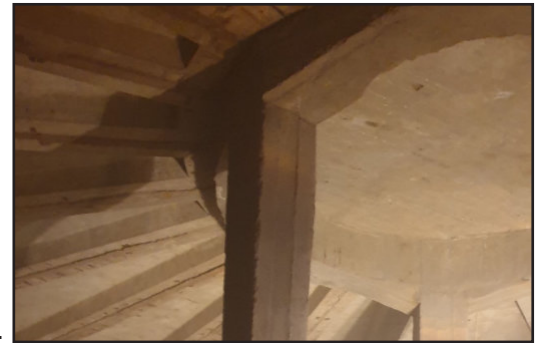
PROBLEM
The concrete walls of the water tank had corroded over time leading to deterioration of the substrate subsequently leading to a poorer quality water quality.

1. Inside of the Water Tank
2. Re-Build of the Concrete using Belzona 4111
3. Spraying Belzona 5811DW2
4. Completed Application
