OFFSHORE HEAT EXCHANGER MAINTENANCE WITH BELZONA.

Severe bimetallic corrosion to offshore heat exchanger endplates.

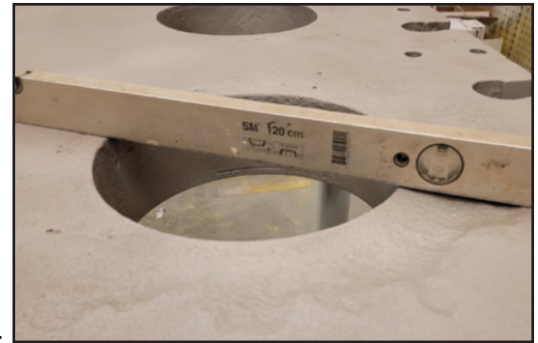
Existing titanium bushings had caused severe bimetallic corrosion on the carbon steel endplate surfaces. The titanium bushing endplate surfaces was in urgent need of rebuilding and protective coating. Design Temperature 90 °C.

1. Corroded area
2. Corroded areas rebuilt using Belzona 1511
3. Endplates coated with Belzona 1391S (Spray applied 2 coats a 375µm) and prepared for forming new bushings with Belzona 1391 Ceramic HT using metal formers.
4. Complete application

The application was carried out in accordance with Belzona System Leaflet HEX-03. Following removal of existing titanium bushings the endplates was grit-blasted to SA 2,5 and 75µm surface profile. All corroded area was rebuilt in stages using Belzona 1511 Super HT Metal. Belzona 1391S was spray applied in 2 coats a 375µm. New bushings was applied/installed with Belzona 1391 Ceramic HT using custom made formers
