BELZONA SUPERWRAP II RETURNS PIPING BACK TO SERVICE IN 48 HOURS

High Temperature, Hydrocarbon Piping

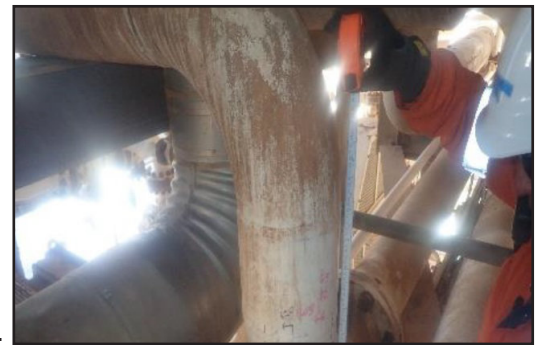
The 220 mm diameter pipe had developed a critical (Class 3) thin wall defect at the bent. The operating temperature was 95°C and the operating pressure was 10 bar. The total defect length was 280 mm in axial.

1. Measuring the corroded pipe
2. Wetting out the Reinforcement Sheet
3. Wrapping the pipe
4. Applying the Release Film over the wrap

The application was completed in accordance with Belzona Know-How System Leaflet VPF-11. The defect area was abrasive blasted to SA 2.5 with a 75 microns profile. Belzona SuperWrap II was applied in accordance with the engineered design as a 6 wrap system, using Belzona 1983 resin to provide a further 12 years service life.
