BELZONA SUPERWRAP II EXTENDS LIFE OF A HIGH TEMPERATURE PIPELINE BY 5 YEARS

High Temperature, Fuel Oil Pipeline

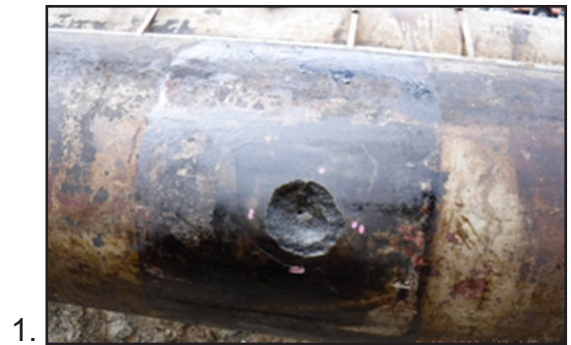
The 406 mm diameter pipe had developed a critical (Class 3) through wall defect calculated at 40 x 40 mm. The operating temperature was 90 °C and the operating pressure was 17.6 bar. The total defect length was 90 mm in axial.

1. Defect in the pipe
2. Defect pit filled with Belzona 1511
3. Application in progress
4. Application completed
