WIND TURBINE LEP REPAIRED WITH BELZONA 5721

APPLICATION SITUATION
Belzona 5721 LEP Coating was applied by rope access at a large wind turbine park in Poland.

PROBLEM
A large energy company in Poland were looking for a solution to repair pitting of the LEP of a wind turbine blades and also supply a LEP coating over the repaired areas.

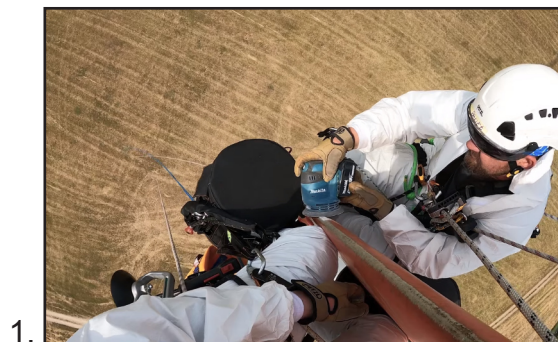
1. LEP Surface Preparation Image
2. Application of Belzona 1221 pit filling
3. Application of Belzona 5721 for the LEP
4. Completed Application

APPLICATION METHOD
The Wind Turbine LEP was repaired in line with Belzona System Leaflet FBC-16.
