# BELZONA SEALS SF6 LEAK IN HYDROELECTRIC POWER STATION

Customer Location: Hydroelectric power generating station  
in British Columbia, Canada

Application: GSS-Gaskets, Seals and Shims

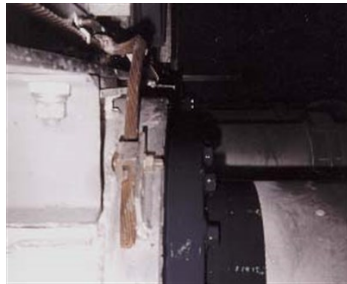
The SF6 dielectric gaseous insulator was leaking from the flange.

- \* Belzona® 2211 (MP Hi-Build Elastomer) was injected between flanges to fill the gap. ,
- \* Completed application. ,
- \* Various leaking flanges were sealed ,

Flanges of SF6 (sulfur hexafluoride) buss bars.

The application was carried out in accordance with Belzona Know-How Leaflet GSS-4.

Since the customer realized significant cost savings, several leaks were repaired. Four and one-half years later the original repair is still holding.
