# Gas Dehydration Plant Heat Exchanger

ID: 10001

**Industry:** Oil & Gas  
**Application:** HEX-Heat Exchangers  
**Substrate:** Carbon steel  
**Products:** Belzona 1391T, Belzona 9111 (Cleaner Degreaser)

**Customer Location:** Southwestern Ontario  
**Application Date:** September 2025

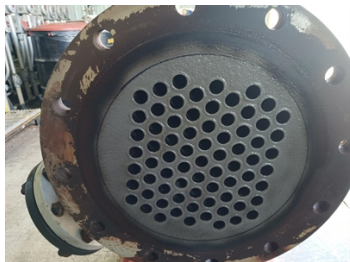
Tube sheet preparation complete grit blasted and cleaned

The customer decided to use the Belzona products, first the tube sheets were grit blasted and cleaned, pitting was found to be minimal so no rebuilding was required only two coats of Belzona 1391T was required.

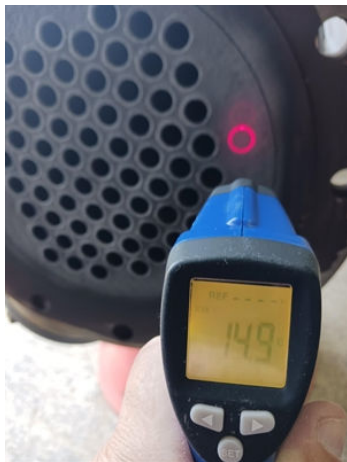
Substrate Temperature checked before starting application

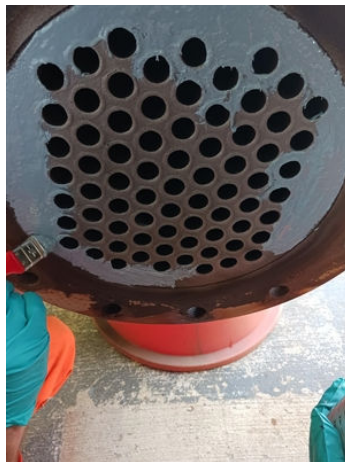
Application of Belzona 1391T Blue

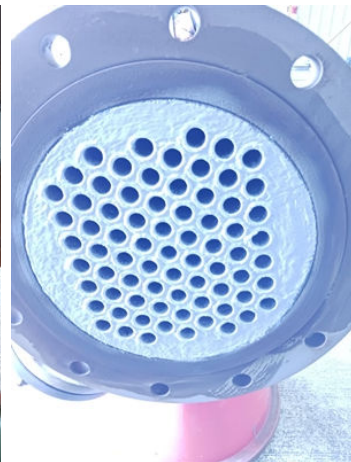
Application of Belzona 1391T Grey completed
