Gas Dehydration Plant Heat Exchanger

ID: 10001

Industry: Oil & Gas
Application: HEX-Heat Exchangers
Substrate: Carbon steel
Products: Belzona 1391T, Belzona 9111 (Cleaner Degreaser)

Customer Location: Southwestern Ontario
Application Date: September 2025

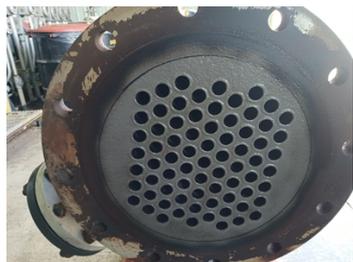
Tube sheet preparation complete grit blasted and cleaned

The customer decided to use the Belzona products, first the tube sheets were grit blasted and cleaned, pitting was found to be minimal so no rebuilding was required only two coats of Belzona 1391T was required.

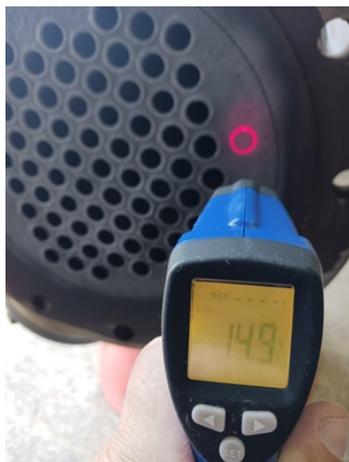
Substrate Temperature checked before starting application

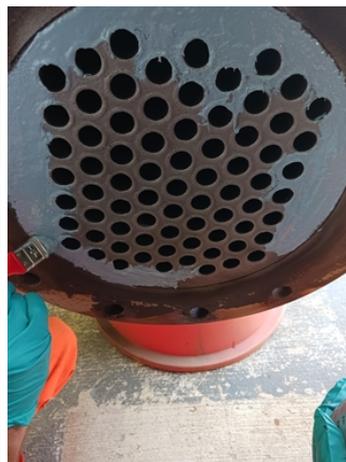
Application of Belzona 1391T Blue

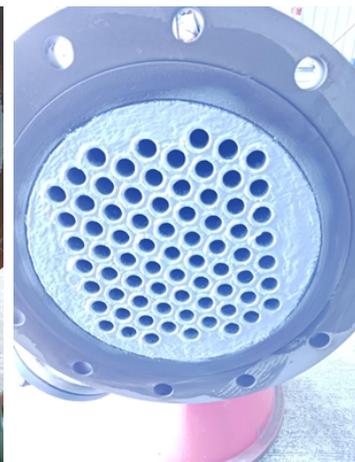
Application of Belzona 1391T Grey completed
