# Belzona solution for In-Situ Shaft Repair at a Power Station

ID: 10002

Industry: Power  
Application: MPT-Mechanical Power Transmission

Substrate: Cast Iron  
Products: Belzona 1111 (Super Metal)

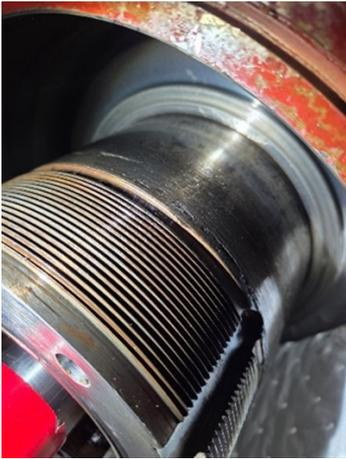
Shaft had suffered damage due to a spun bearing in service, leading to reduced performance and efficiency in operations.

Damage on shaft caused by a spun bearing in service

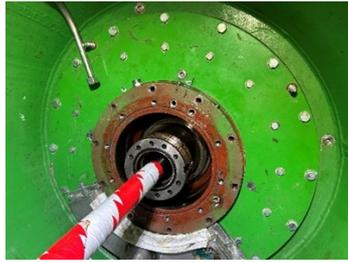
Preparation for shaft repair in situ

The shaft was prepared and rebuilt in situ with Belzona 1111 (Super Metal). Once the product was fully cured, the shaft was machined to original dimensions.

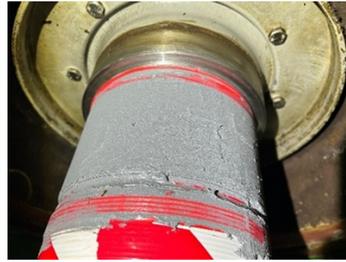
Belzona 1111 (Super Metal) was applied to restore the surface without the need to disassembling the equipment

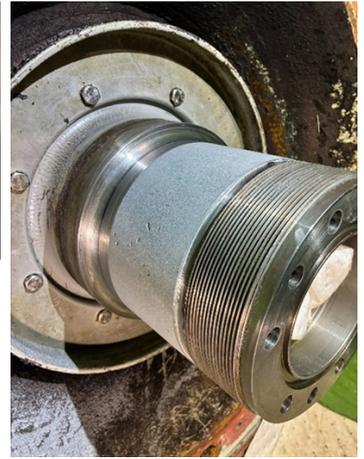
Belzona 1111 (Super Metal) was left to cure and machined to original dimensions.
