Belzona solution for In-Situ Shaft Repair at a Power Station

ID: 10002

Industry: Power
Application: MPT-Mechanical Power Transmission

Substrate: Cast Iron
Products: Belzona 1111 (Super Metal)

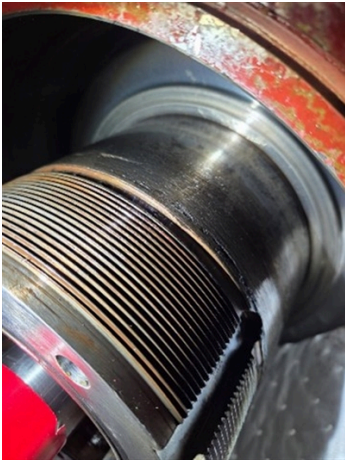
Shaft had suffered damage due to a spun bearing in service, leading to reduced performance and efficiency in operations.

Damage on shaft caused by a spun bearing in service

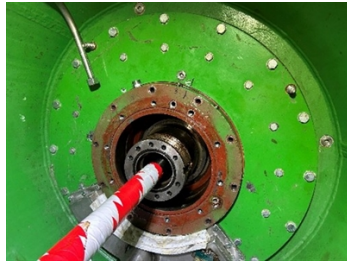
Preparation for shaft repair in situ

The shaft was prepared and rebuilt in situ with Belzona 1111 (Super Metal). Once the product was fully cured, the shaft was machined to original dimensions.

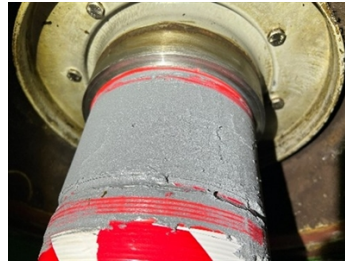
Belzona 1111 (Super Metal) was applied to restore the surface without the need to disassembling the equipment

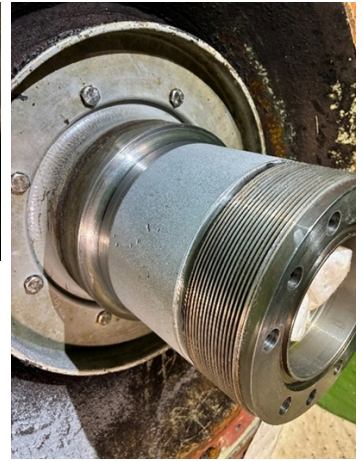
Belzona 1111 (Super Metal) was left to cure and machined to original dimensions.
