Repairs to corroded internal sealing faces at a paper mill

Application: CEP-Centrifugal Pumps

Substrate: Cast Iron

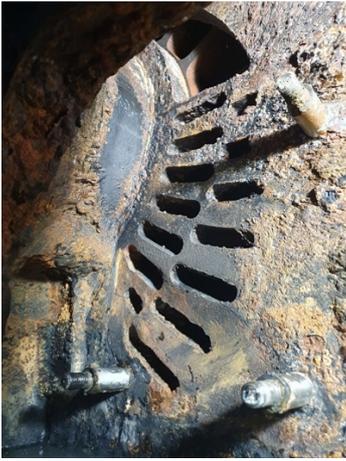
The customer had severely corroded sealing faces. Due to difficult with access, grit blasting was not an option and there was only a very short window of time to carry out any repairs. Customer required a long lasting permanent solution to the issue.

Heavily corroded sealing face.

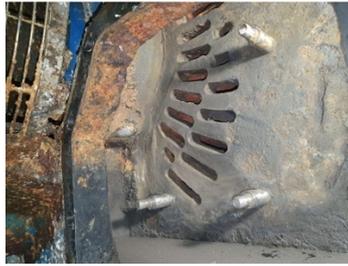
Surface preparation carried out and area degreased

The area's were degreased and then wetted out using Belzona 1161 Super UW-Metal (Surface tolerant product) and allowed to cure.

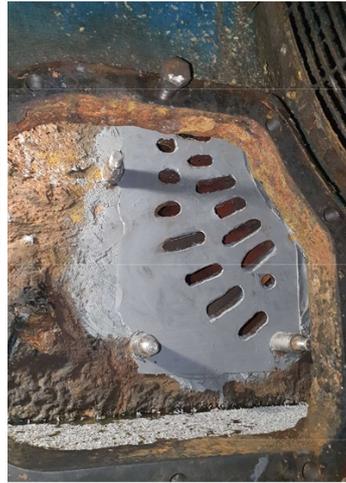
Former plate applied to defective area and Belzona 1161 allowed to cure

Belzona 1311 was then applied to the former plates which had been coated with Belzona 9411 Release Agent, and then put up against the worn faces and allowed to cure.

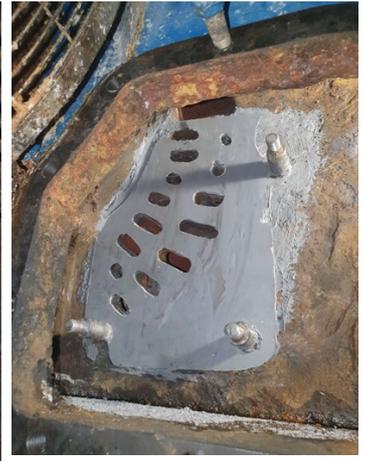
Sealing face formed at drive and non-drive end.
