Belzona Solution for Internal Coating to 48 Inch Diameter Test Separator - Vessel

ID: 10006

Industry: Oil & Gas
Application: TCC-Tanks and Chemical Containment Areas
Substrate: Carbon steel
Products: Belzona 1391T

Customer Location: ABU DHABI, UNITED ARAB EMIRATES
Application Date: August 2025

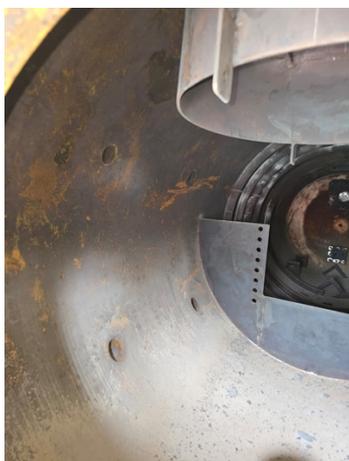
The Test separator suffered severe erosion-corrosion, compromising equipment integrity and safety.

One of our offshore clients experienced significant internal deterioration of their 3-phase test separator due to erosion-corrosion. The equipment operates at 121°C and processes sour hydrocarbons, which contributed to the accelerated degradation. This condition severely compromised the integrity and performance of the unit, raising serious concerns about operational reliability and safety. A comprehensive technical assessment was carried out, and appropriate mitigation measures were implemented to prevent further damage and restore the system's functionality.

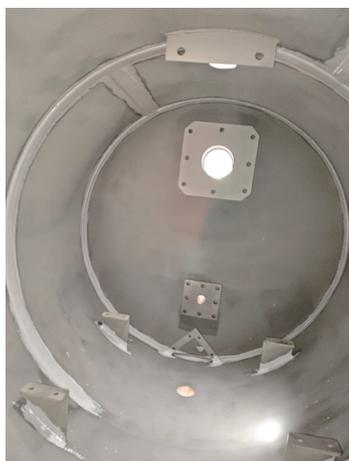
Surface preparation was carried out via grit blasting to SA 2.5 standard.

The application was performed in strict accordance with Belzona Know-How System Leaflets TCC-5, ensuring adherence to industry best practices for corrosion protection and extended equipment lifespan. Surface preparation was carried out via grit blasting to SA 2.5 standard, followed by thorough cleaning using Belzona 9111 (Cleaner Degreaser). The damaged areas were subsequently coated with two layers of Belzona 1391T, providing durable, long-term protection.

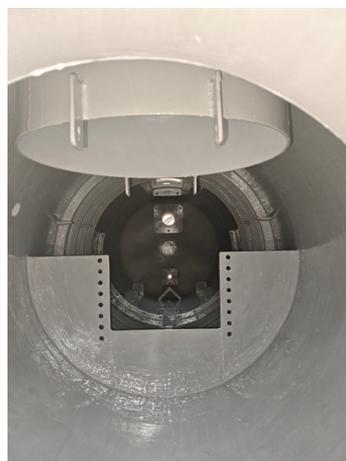
The damaged areas were then treated with a first coat of Belzona 1391T.

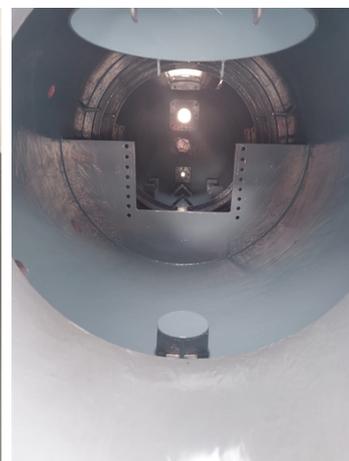
A second coat of Belzona 1391T was applied to ensure durable, long-term protection.
