# Slurry Line Leak Repair – Cold-Applied Composite Solution at Cement Plant

ID: 10007

Application: VPF-Valves, Pipes and Fittings

Application Date: September 2025

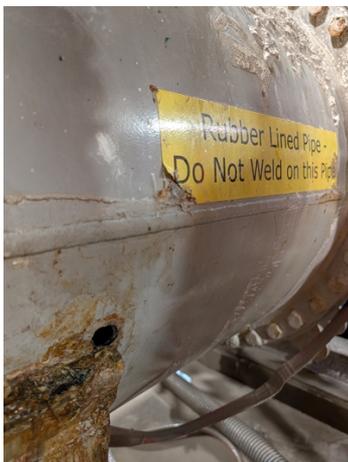
A rubber-lined slurry pipe inside a cement plant has developed an approx 1-inch diameter hole that has penetrated through the wall, resulting in an active leak of abrasive slurry.

A hole in a pipe before the application.

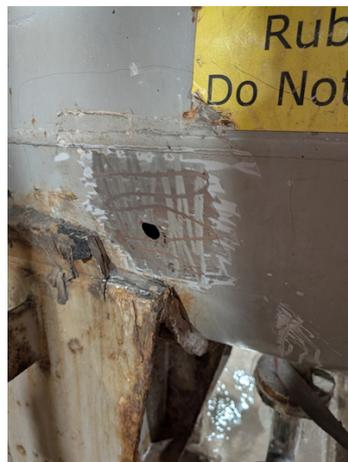
The surface has been prepared for the application

Leaking pipe surface roughened with the power tool to SSPC-SP10 standard, Surface cleaned and roughened to ensure high adhesion

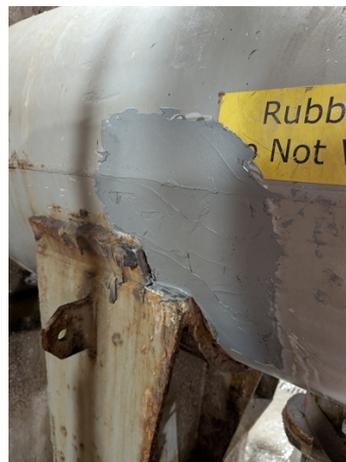
Rebuild with Belzona 1161 with 9341 mesh

Belzona 1161 applied over leak zone, 9341 mesh embedded within 1161 to arrest leak and rebuild wall thickness. Cured and profiled as a foundation for the wrap system

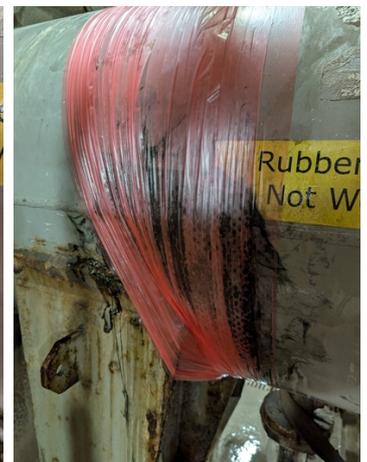
Strengthening the repair with Super Wrap II with Belzona 1984

SuperWrap II system applied using 1984 resin with 9381 carbon fibre wrap and 9382 consolidation film.  
Applied in multiple layers to meet the thickness and strength required.
