Application of anti-slip surface on Millennium Bridge control room

ID: 10008

Industry: Local Authorities & Municipalities
Application: FPA-Floor Problem Areas
Substrate: Concrete
Products: Belzona 5811 (Immersion Grade)

Customer Location: Newcastle
Application Date: June 2025

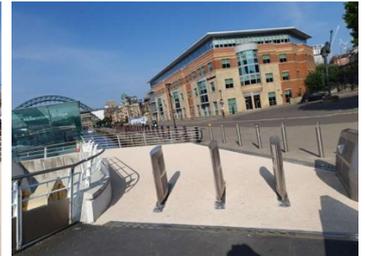
1mm of Belzona was applied and blended with aggregate

The area was power washed prior to application. Belzona 5811 was applied at approximately 1mm thick and blended with aggregate to match existing path colour.
