# Belzona Protects Ball Mill Braces

Industry: *Mining & Quarrying*  
 Application: *SHM-Solids Handling Machinery*

Customer Location: *Larose, Louisiana*  
 Application Date: *September 2025*

Substrate: *Carbon steel*  
 Products: *Belzona 1331, Belzona 9111 (Cleaner Degreaser)*

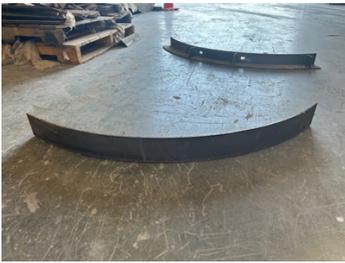
Customer was having high erosion on the braces supporting a ball mill handling Barite. Due to the high velocity and operating temperature of 300F, the Barite powder in the air was degrading the braces to no use within 2-3 months.

New upper and lower braces at customer location.

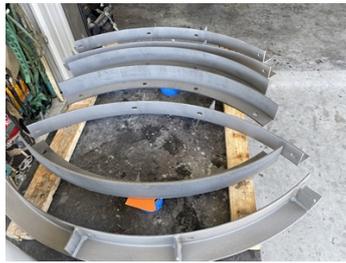
Braces blasted and prepped for application at Belzona/AAS location.

Braces were blasted and cleaned with Belzona 9111. Braces were then twice coated with Belzona 1331 by hand.

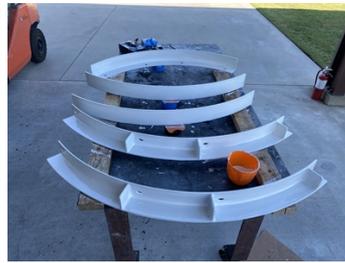
First coat of Belzona 1331 applied.

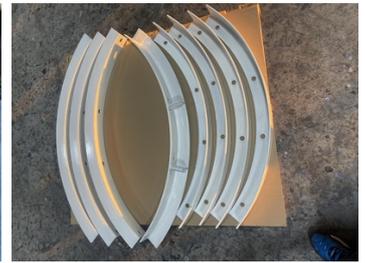
Second coat of Belzona 1331 applied and final product.
