Belzona Repairs Worn Impeller and Pump

ID: 10010

Application: CEP-Centrifugal Pumps

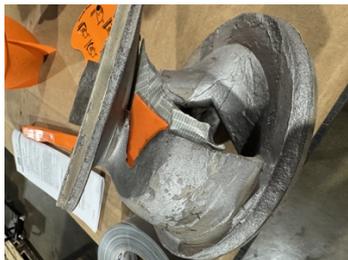
the impeller had a worn blade that needed to be rebuilt following years being in service. They also wanted to coat it for future protection.

Impeller Blade Shown with Missing Metal

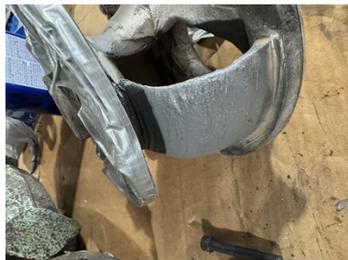
Belzona 1111 Formed to Fill Missing Area and then wrapped with Reinforcement Cloth and More Belzona 1111

First, we cut a piece of a belzona mixing board and duct taped it to the back of the impeller blade.

We then applied Belzona 1111 to the missing area and onto the existing metal by about an inch.

Once cured, we removed the former and applied More Belzona 1111 to build up and engrained reinforcement cloth.

While mostly cured but still soft, we sanded some areas lightly to contour.

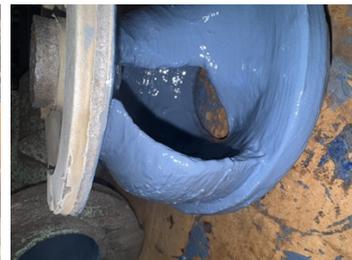
2nd Coat of Belzona 1321 Applied

After curing, we applied 2 coats of Belzona 1321.
