Refurbishment of Vertical Pump Suction Bells Using Belzona for Protection Against Saltwater Exposure

ID: 10011

Industry: Oil & Gas
Application: CEP-Centrifugal Pumps
Substrate: Cast Iron
Products: Belzona 1111 (Super Metal), Belzona 5821

Customer Location: Saudi Arabia
Application Date: April 2024

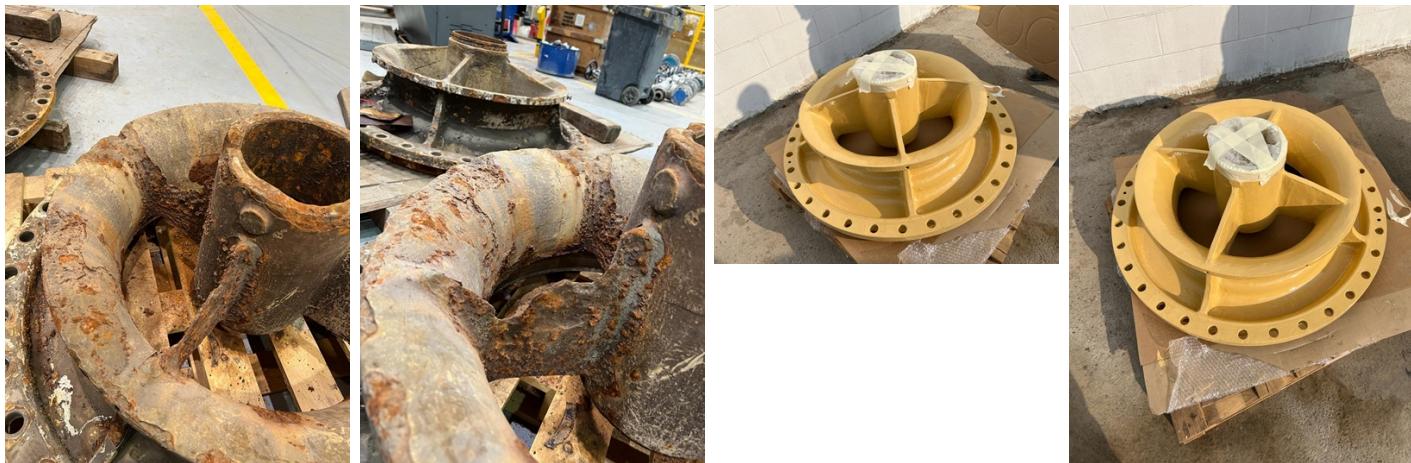
The supports and flow straighteners on the suction bell were heavily corroded and eroded due to prolonged exposure in seawater service.

The suction bells exhibit severe corrosion and erosion as a result of prolonged exposure to saltwater.

Suction bells deteriorated by severe saltwater corrosion and erosion.

Suction bells repaired with Belzona 1111 (Super Metal) and overcoated with Belzona 5821

Belzona 5821 overcoat applied to protect equipment operating in immersed conditions

1. The worn-out metal at the support/flow straightener areas were rebuilt with Belzona 1111 (Super Metal) and reinforcement sheet.
2. The rebuilt sections and the remaining surfaces were overcoated with Belzona 5821 to enhance durability under immersed operating conditions.

Belzona 1111 (Super Metal) was applied to rebuild all pitted areas. For heavily worn areas at the supports/flow straighteners, additional reinforcement sheet was installed to strengthen the repair. The suction bell was subsequently top coated with Belzona 5821 for long term immersion protection in seawater service.
