# Particulate Filter Vessels Internal Coating

ID: 10013

Industry: *Other*  
Application: *TCC-Tanks and Chemical Containment Areas*  
Substrate: *Carbon steel*  
Products: *Belzona 1391T, Belzona 1511 (Super HT-Metal)*

Customer Location: *Saudi Arabia*  
Application Date: *October 2024*

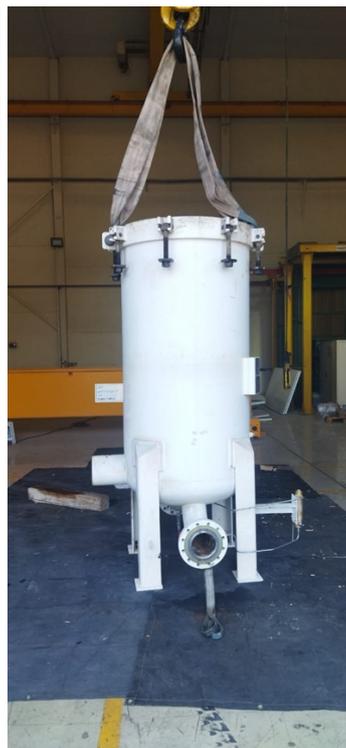
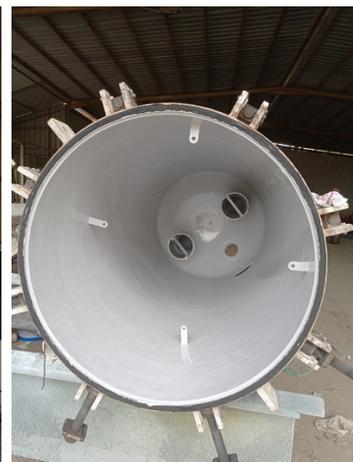
*The existing lining delaminated and failed in many locations, causing localized corrosion.*

Existing lining failed and started to show sign of corrosion

Old lining was removed before the repair

Coating during process

Completed application

The repair of the filter was done in just two days, saving downtime and operational cost.

Before the new coating was applied, all loose materials were removed. The coating was subsequently applied with basic tools, a brush and plastic applicator, to install a protective barrier for the internal vessel lining.
