# Repair and Protection of the Strut Arms, Housing, and Shaft Using Belzona

ID: 10014

Industry: *Military*  
Application: *SOS-Ships and Offshore Structures*  
Substrate: *Other*  
Products: *Belzona 1111 (Super Metal), Belzona 5821*

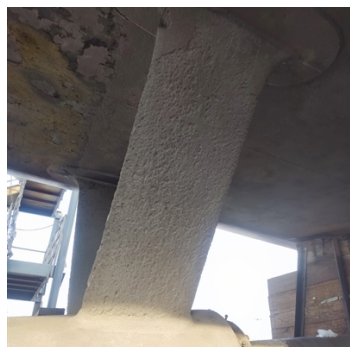
*The strut arms, housing, and shaft of a marine vessel were heavily corroded due to prolonged exposure to seawater.*

Corrosion attack was caused by prolonged exposure to seawater

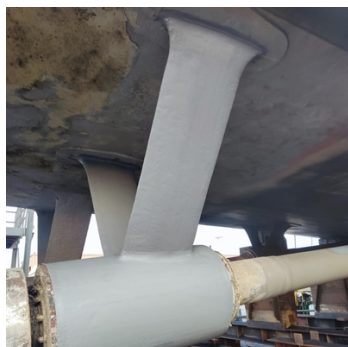
Belzona 1111 (Super Metal) was used to rebuild and fair the pitting damage on the substrate

Belzona 1111 (Super Metal) was applied to rebuild areas of pitting and to fair the substrate with the aid of plastic applicators. After the surface rebuilding was completed, the first coat of Belzona 5821 (dusty grey) was applied. After the first coat, the second coat of Belzona 5821 (yellow) was applied to complete the protective system.

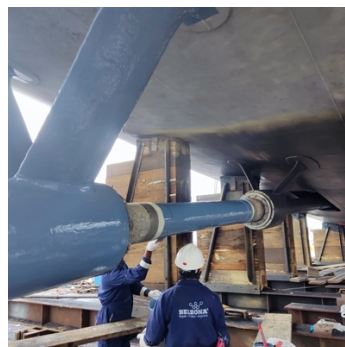
Application of the first coat of Belzona 5821

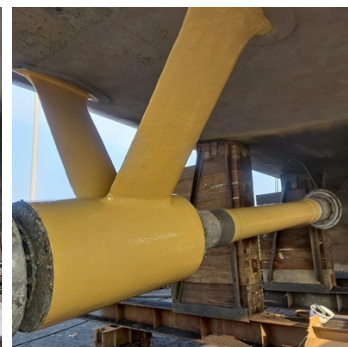
Application of second coat of Belzona 5821
