# Repair and Protection of the Strut Arms, Housing, and Shaft Using Belzona

ID: 10014

Industry: Military  
Application: SOS-Ships and Offshore Structures

Substrate: Other  
Products: Belzona 1111 (Super Metal), Belzona 5821

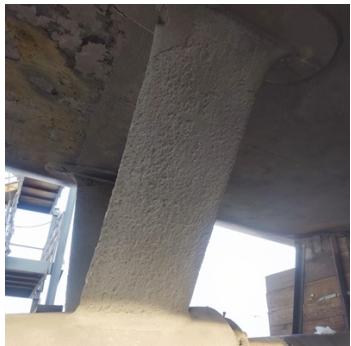
The strut arms, housing, and shaft of a marine vessel were heavily corroded due to prolonged exposure to seawater.

Corrosion attack was caused by prolonged exposure to seawater

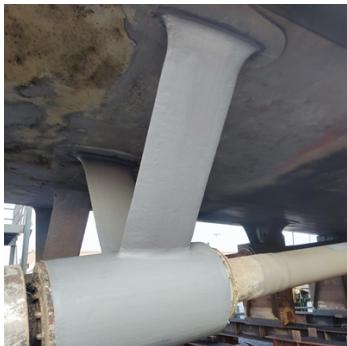
Belzona 1111 (Super Metal) was used to rebuild and fair the pitting damage on the substrate

Belzona 1111 (Super Metal) was applied to rebuild areas of pitting and to fair the substrate with the aid of plastic applicators. After the surface rebuilding was completed, the first coat of Belzona 5821 (dusty grey) was applied. After the first coat, the second coat of Belzona 5821 (yellow) was applied to complete the protective system.

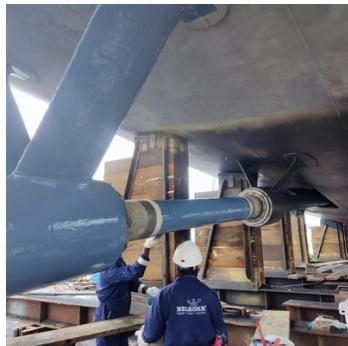
Application of the first coat of Belzona 5821

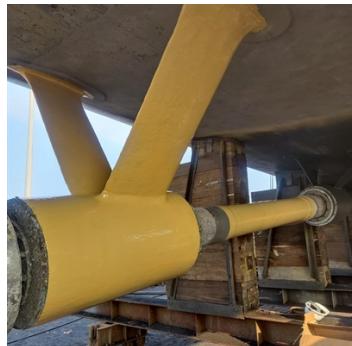
Application of second coat of Belzona 5821
