# Flange Face Forming Technique Restores Damaged Sand Filter Flange

ID: 10015

Industry: Water / Wastewater

Application: VPF-Valves, Pipes and Fittings

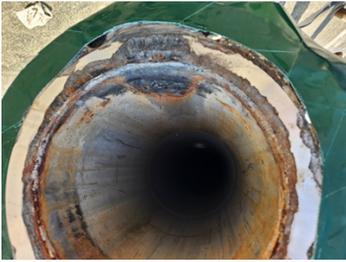
Damaged flange face on stainless-steel spools of the sand filters

1. Apply release agent on the former and allow it to cure
2. Apply Belzona 1111 (Super Metal) on both the flange face and the former that has been coated with Belzona 9411 release agent
3. Install the former on the prepared flange face and use the bolts to tighten the former to the flange face
4. Remove any excess Belzona 1111 (Super Metal)
5. Once the product is cured, remove the former.

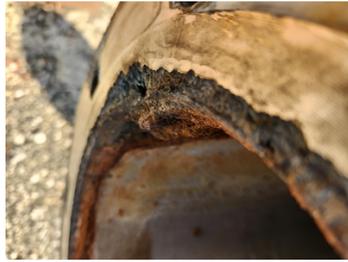
Close-up of the damaged flange face on the stainless-steel sand filter spool.

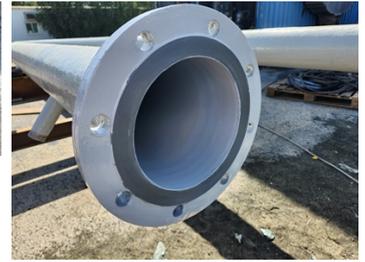
Complete application of flange face forming
