Belzona protects concrete & drainage areas

ID: 10017

Industry: Power
Application: FPA-Floor Problem Areas
Substrate: Concrete
Products: Belzona 5811 (Immersion Grade), Belzona 5831 (ST-Barrier), Belzona 9111 (Cleaner Degreaser)

Customer Location: Orapa, Botswana
Application Date: October 2025

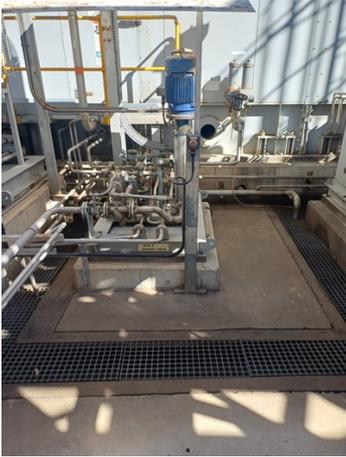
Areas were contaminated by accidental oil and diesel spillages causing environmental complications.

Contaminated areas before cleaning commences.

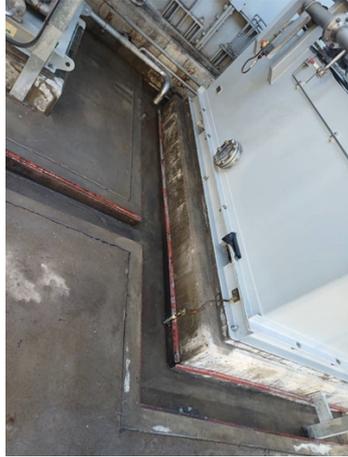
Cleaning in progress. Belzona 9111 degreaser, concrete cleaner & a water based detergent were used and then high pressure washed with clean water.

Contaminated areas were degreased with Belzona 9111 & concrete cleaner. They were then cleaned with a water based detergent and pressure washed with clean water. Belzona 5831 was used as a first coat followed by a top coat of Belzona 5811.
