Belzona SuperWrap II saves 24" Exhaust Pipe at Steel Mill

ID: 10019

Industry: *Steel & Metal Processing* Customer Location: *Detroit, MI*
Application: *VPF-Valves, Pipes and Fittings* Application Date: *November 2020*
Substrate: *Carbon steel*
Products: *Belzona 1212, Belzona SuperWrap II, Belzona 9111 (Cleaner Degreaser)*

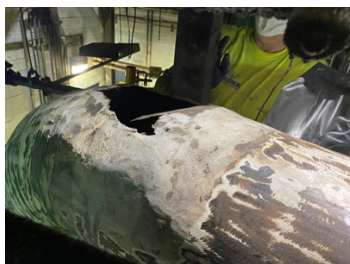
Pipe was previously repaired with fiberglass. Thin gage steel was used to make a form and bonded form with 1212 to pipe. Then we proceeded to wrap pipe (3 spirals) with 1981 Super Wrap system.

Holed Casing

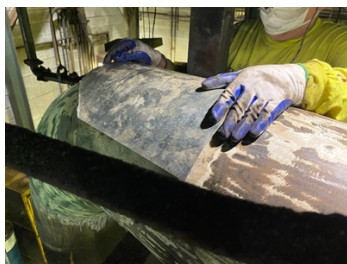
Cold Bonding Former with Belzona 1212

Pipe was previously repaired with fiberglass. We used thin gage steel to make form and bonded form with 1212 to pipe Then we proceeded to wrap pipe (3 spirals) with Belzona 1981 SuperWrap II system.

Pipe was prepared using MBX tool then flooded with Belzona 9111 (Cleaner/Degreaser). Belzona 1212 was mixed and applied followed by three wraps of Belzona Superwrap II.

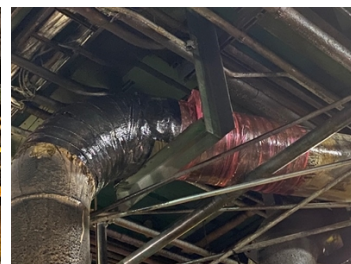
Finished Application
(Consolidation Tape still needs removed)

This repair kept the mill from shutting down to replace an exhaust pipe.
