Condenser Cave In

ID: 10021

Industry: Power
Application: HEX-Heat Exchangers
Substrate: Carbon steel
Products: Belzona 1121 (Super XL-Metal), Belzona 5821

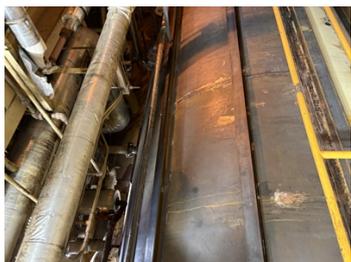
New metal work installed on condenser

Side wall had caved in and leaking. Plant replaced wall with new metal. We then applied Belzona 1121 for rebuild and coated complete internals with Belzona 5821.

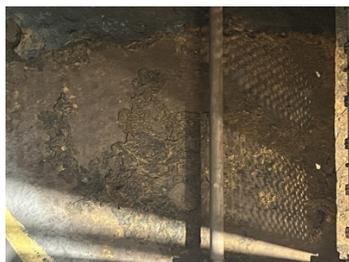
Existing internal metal before preparing for coating

Grit blasted with Black beauty to SP-10, wiped down with MEK, applied 120 kg's of Belzona 1121 and two coats of Belzona 5821

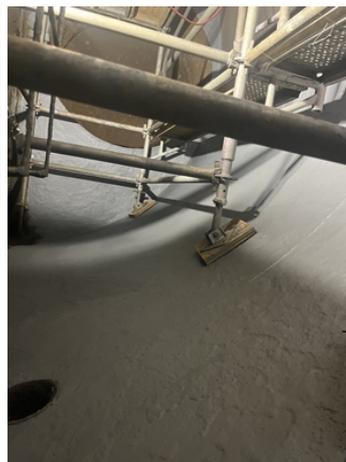
Substrate after applying Belzona 1121

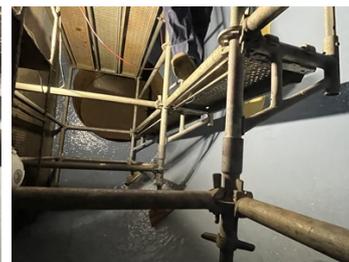
Substrate after applying Belzona 5821
