Belzona Solution for Tank Leak Repair by Plate Bonding Method

Application: TCC-Tanks and Chemical Containment Areas

Substrate: Carbon steel

Products: Belzona 1161 (Super UW-Metal), Belzona 9611 (ES-Metal)

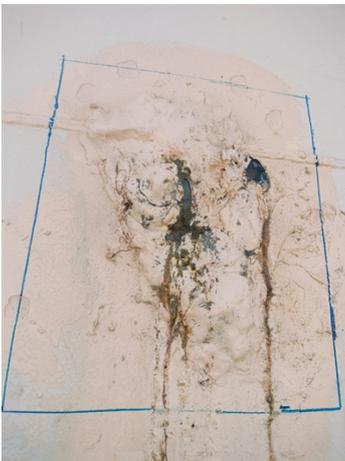
A leak in the wall of the customer's fire water tank created a hole and disrupted operations.

A customer encountered a significant issue with their fire water tank, where a leak had developed in the wall, resulting in a hole. This problem was causing operational disruptions and posed a risk to their processes. To minimize downtime and restore normal operations as quickly as possible, an immediate and effective repair solution was required.

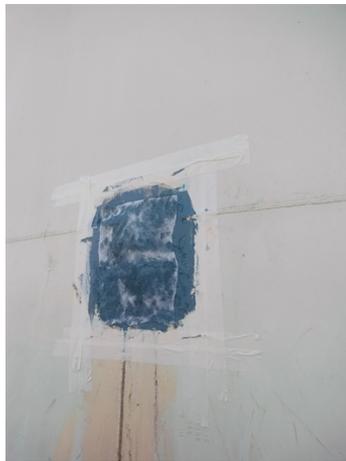
Following cleaning, the substrate was grit-blasted, and Belzona 9611 (ES-Metal) was applied to effectively seal the leak.

1. After thorough cleaning, the surface plate was grit-blasted using power tools to achieve the required profile and prepare the substrate.

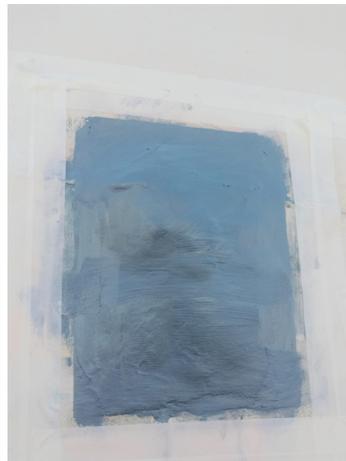
To strengthen the repair area, Belzona 1161 (Super UW-Metal) was applied before proceeding with plate bonding.

2. Belzona 9611 (ES-Metal) was applied initially to seal the leak, followed by Belzona 1161 to reinforce the material prior to plate bonding.

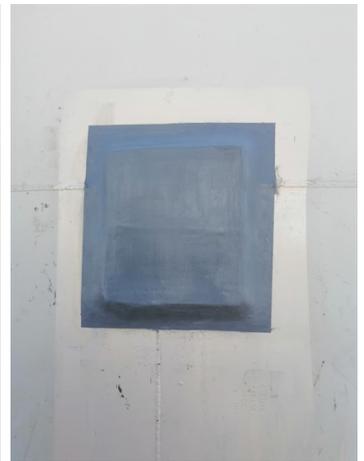
Belzona 1161 (Super UW-Metal) was applied via the plate bonding method.

3. A subsequent layer of Belzona 1161 (Super UW-Metal) was applied to further rebuild the surface and achieve a smooth, finished profile.
