Multiple sea water leaks with structural reinforce with Belzona SuperWrap II

ID: 10026

Industry: Water / Wastewater
Application: VPF-Valves, Pipes and Fittings
Substrate: Stainless-steel
Products: Belzona 1161 (Super UW-Metal), Belzona 1212, Belzona 1982 (SuperWrap II), Belzona SuperWrap II, Belzona 5811DW2 (DW Immersion Grade)

Customer Location: Barcelona, Cataluña, Spain
Application Date: September 2025

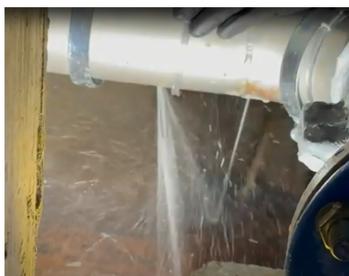
This was the problem of pressure we had.

Due to the pressure that the water generated was really high so it was difficult to seal the crack.

First of all, tried to seal the crack with Belzona 1212 via plate bonding and jubilees. After that, seal all the jubilees and the plate with Belzona 1212 and Belzona 1161, later on we would use Belzona SuperWrap II with Belzona 1982 and Belzona 9381. Finally, on top of that we would give it a coating of Belzona 5811DW2.

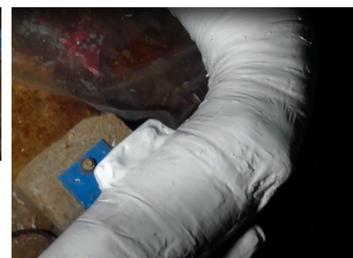
Finally in this photo we show the final look of the repair.
