Multiple sea water leaks with structural reinforce with Belzona SuperWrap II

ID: 10026

Application: VPF-Valves, Pipes and Fittings

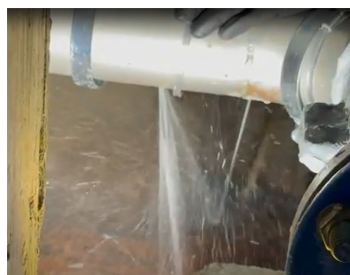
This was the problem of pressure we had.

Due to the pressure that the water generated was really high so it was difficult to seal the crack.

First of all, tried to seal the crack with Belzona 1212 via plate bonding and jubilees. After that, seal all the jubilees and the plate with Belzona 1212 and Belzona 1161, later on we would use Belzona SuperWrap II with Belzona 1982 and Belzona 9381. Finally, on top of that we would give it a coating of Belzona 5811DW2.

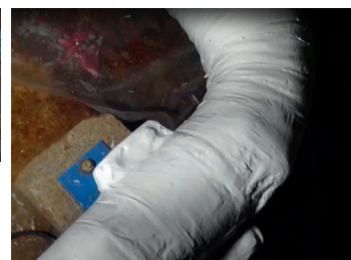
Finally in this photo we show the final look of the repair.
