# BELZONA MOULD IS LONG TERM SUCCESS

Customer Location: Arts Museum, Bradford, UK

Application: WPA-Wall Problem Areas

Application Date: March 1982

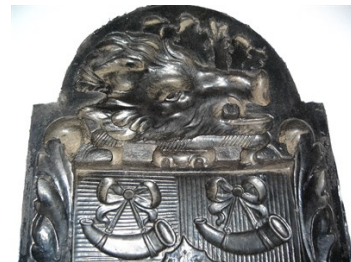
*Six of the original coat-of-arms had been damaged and needed re-creating*

- \* The original coat-of-arms ,
- \* A casting from the mould in 1982 ,
- \* The mould in February 2008 ,
- \* Close up shows the detail is still clearly evident 25 years later ,

Application was carried out following details in Belzona Know-How System Leaflet WPA-6. Belzona® 9411 was applied to the original coat-of-arms. Once dry, the Belzona Fluid Rubber was initially brushed over the surface before pouring more product to obtain the required thickness. This ensured all the detail from the original coat-of-arms was reproduced in the Belzona mould.

The mould was inspected in February 2008, over 25 years since its creation. Aside from a few minor issues that the customer had easily corrected, the condition was still excellent and usable for the museums latest restoration. The toughness and stability of the Belzona Elastomers allow them to repeatedly be used to create accurate replicas of the original pattern.
