BELZONA STEMS LEAK AND REPLACES FAILED SEWAGE TANK BASE SEAL

ID: 10031

Customer Location: ELMIRA, ONTARIO

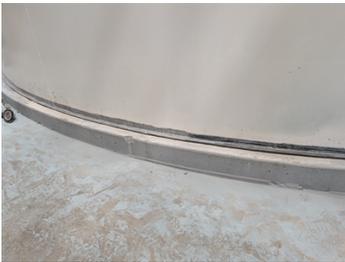
Tank base during surface preparation

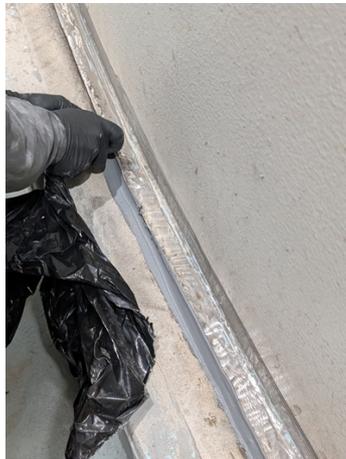
Stemming the leak with Belzona 1161

Sewage tank was experiencing leaks from various parts of the seal. Belzona discussed various options of repair to firstly stem the leak, seal the perimeter around the seal and application of the microporous solution.

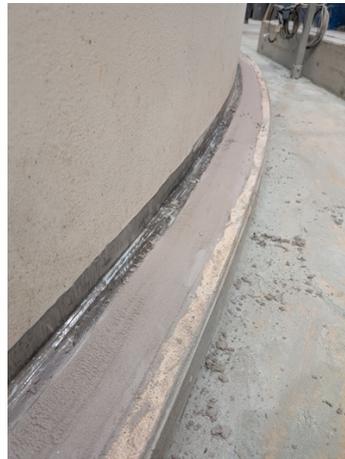
Sealing the perimeter with Belzona 4111

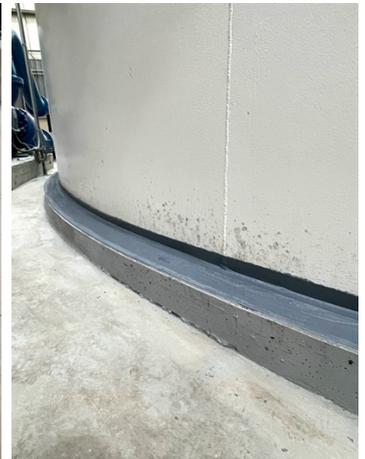
After application of two coats of Belzona 3111 with mesh.
