BELZONA HELPS REBUILD TOLERANCE LOSS DUE TO MILL SCALE

ID: 10032

Industry: *Other*
 Application: *GSS-Gaskets, Seals and Shims*
 Substrate: *Carbon steel*
 Products: *Belzona 1121 (Super XL-Metal)*

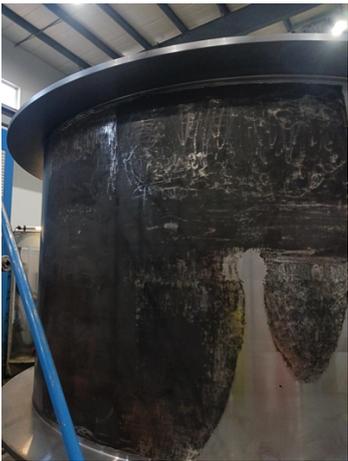
Newly fabricated cylinder experiencing reduction in diameter due to mill scale formation on some parts of the surface.

Cylinder with millscale

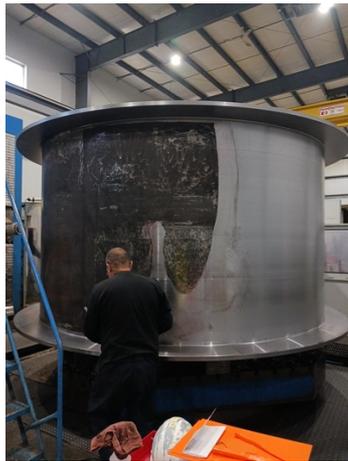
During surface preparation

Surface preparation was carried out to the level of cleanliness of SSPC SP11. Then thorough solvent cleaning was done before the application of Belzona 1121 was carried out. Surface was then machined to the required diameter afterwards.

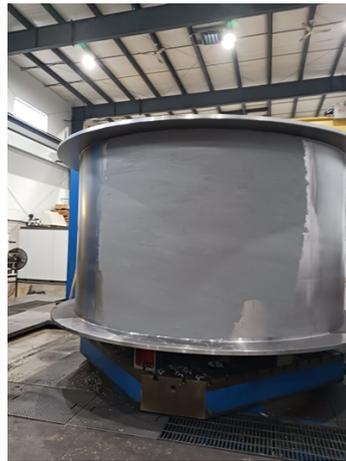
After rebuilding with Belzona 1121

Newly fabricated cylinder experiencing reduction in diameter due to mill scale formation on some parts of the surface. Belzona was used to build the surface and machined to the required tolerance.

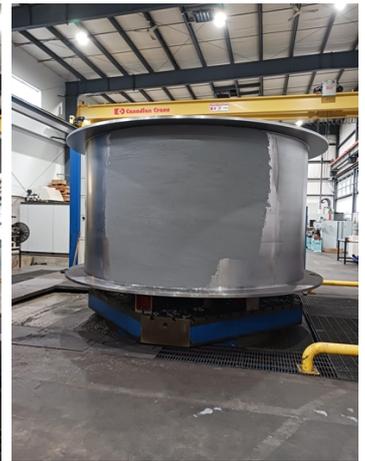
After machining
