Rebuild and Protect Firewater Pumps

ID: 10033

Industry: Marine
Application: CEP-Centrifugal Pumps
Substrate: Carbon steel
Products: Belzona 1311 (Ceramic R-Metal), Belzona 1321 (Ceramic S-Metal)

Customer Location: Pascagoula, Mississippi
Application Date: April 2025

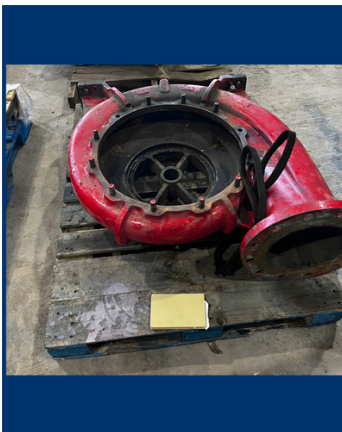
Our customer required restoration of metal loss to recover optimal flow rate and to protect the pump casing from ongoing damage caused by saltwater, sand, and debris.

Before Picture of the Pump Case

Belzona MS, Inc. will clean pump casings with Acetone, tape off the area of repair, and start rebuilding the metal loss with Belzona 1311 R Metal.

Once The Belzona 1311 R Metal has cured enough to over coat with Belzona 1321 S Metal (Per IFU), the Technical Consultants will apply the first coat and then the second coat.

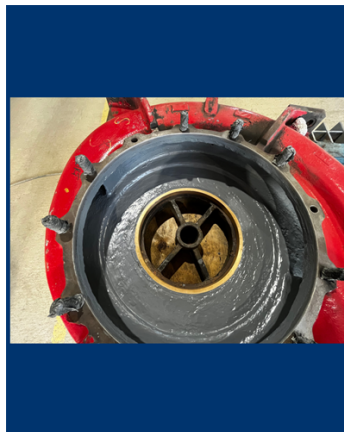
After Picture of the Pump Case

Then A machinist was present and checked the tolerance specifications and ensure proper fitment when the impeller/pump casing is reassembled.

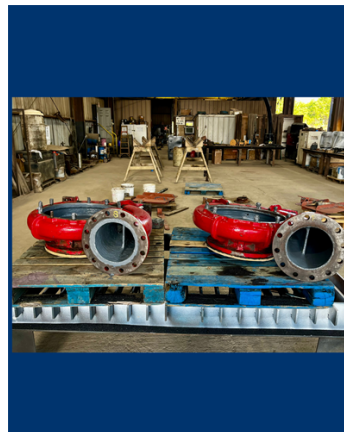
After picture of both Fire Water Pumps

Belzona 1311 (Ceramic R-Metal) and Belzona 1321 (Ceramic S-Metal) were utilized to repair two (2) fire water pumps. The total project consisted of Belzona 1311 /1321, consumables and two days of labor. Although the customer did not disclose the cost of purchasing two new fire water pumps, it is reasonable to conclude that the replacement cost and associated lead time would have been significantly higher, likely delaying the completion of the customer's vessel.
