Rebuild and Protection of Firewater Pumps using Belzona

ID: 10033

Industry: *Marine*
Application: *CEP-Centrifugal Pumps*
Substrate: *Carbon steel*
Products: *Belzona 1311 (Ceramic R-Metal), Belzona 1321 (Ceramic S-Metal)*

Customer Location: *Pascagoula, Mississippi*
Application Date: *April 2025*

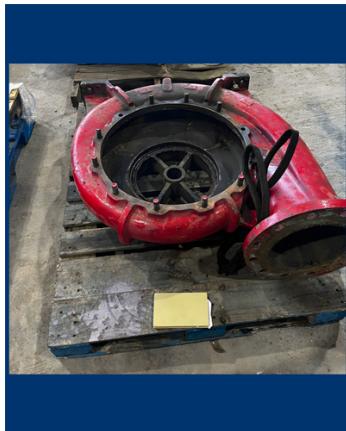
Our customer required restoration of metal loss to recover optimal flow rate and to protect the pump casing from ongoing damage caused by saltwater, sand, and debris.

Before Picture of the Pump Case

Belzona Mississippi, Inc. will mobilize on site after the Surface preparation (3 mil blast profile, Near white finish) has been completed by Signet MaritimeCorporation (customer).

Belzona MS, Inc will clean pump casings with Acetone, tape off the area of repair, and start rebuilding the metal loss with Belzona 1311 R Metal.

Once The Belzona 1311 R Metal has cured enough to over coat with Belzona 1321 S Metal (Per IFU), the Technical Consultants will apply the first coat and then the second coat.

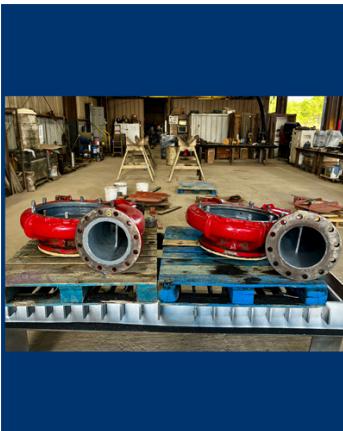
After picture of both Fire Water Pumps

Belzona 1311 (Ceramic R-Metal) and Belzona 1321 (Ceramic S-Metal) were utilized to repair two (2) fire water pumps. The total project consisted of Belzona 1311 /1321, consumables and two days of labor. Although the customer did not disclose the cost of purchasing two new fire water pumps, it is reasonable to conclude that the replacement cost and associated lead time would have been significantly higher, likely delaying the completion of the customer's vessel.
